# PROPERTY INSPECTION REPORT

**Robert Keesser**  
**Kee-Way Inspection Services**  
**24gl00181100**

**123 Inspection Rd.**

**Inspection prepared for: Sample Report**

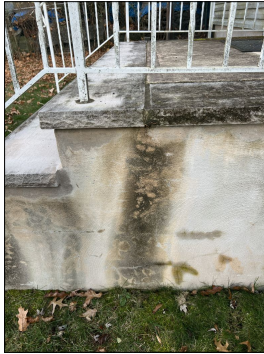
Moss, lichens and/or algae observed at the stairs. This is a sign of standing water and can be slippery when wet. Recommend treating moss during its growing season (wet months) with a moss/algae killer. Location: Rear of home (Purple)

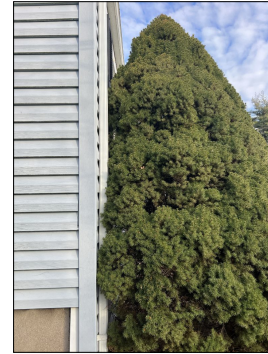
Landscaping or vegetation was near or in contact with the structure and/or garage. Maintain to prevent damage, pest/WDI/rodent intrusion and moisture intrusion to structure. (Blue)

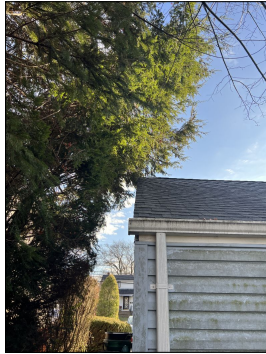
Keep tree branches that are near, on or overhanging roofs trimmed. Tree branches can damage a roof very quickly if not trimmed back and left overhanging or laying on the roof. Damaged to shingles is possible that can be caused by the branches and leaves. Evaluate and repair. (Purple)

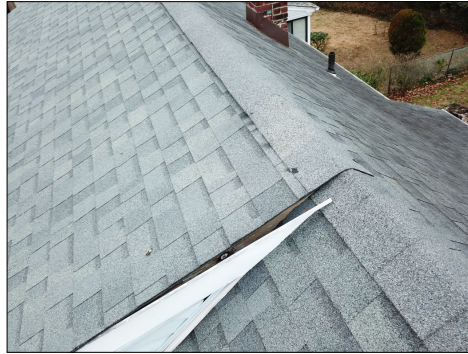
Step flashing is Missing. Step flashing helps prevent water intrusion. Flashing plays an important role in preventing water intrusion and premature damages to the wood components. Evaluate and replace. (Red)

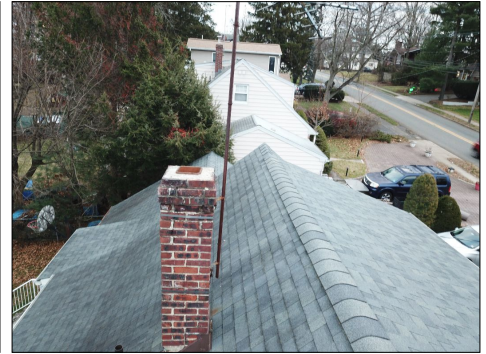
Missing rain cap. Water intrusion can cause damage to the chimney and the appliances that are connected to it. Pests/rodents may enter into the chimney as well. Recommend installing. Evaluate and repair. (Blue)

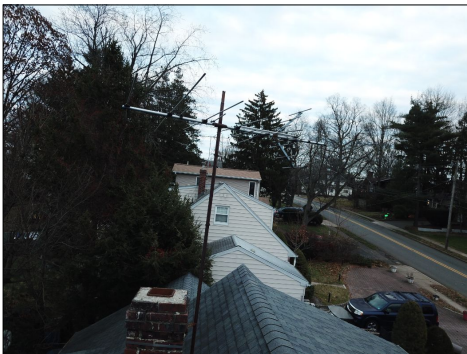
Attachments, satellite dish, antenna—[Satellite dish/antenna] attached to chimney. Chimneys typically are not constructed to support anything other than the chimney itself, and the structural and functional integrity of the chimney can be compromised when additional structural, mechanical, or utility systems are attached to them with screws, bolts, etc. Recommend having [satellite dish/antenna] moved and further evaluation by licensed chimney professional to ensure integrity and proper function of chimney. (Blue)

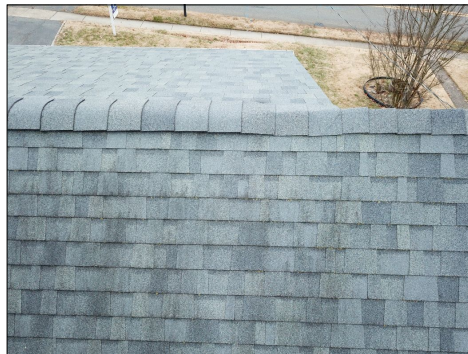
Moss, algae and/or lichen on roof. This can lead to the premature failure of the roof and subsequent leaks. Recommend treating moss during its growing season (wet months) with a moss killer. (Purple)

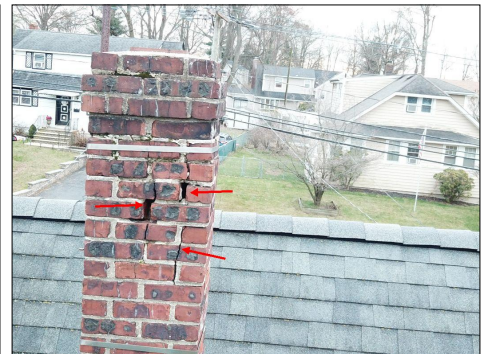
The brick and/or mortar at the chimney was damaged. Areas of mortar were missing, which can lead to intrusion of water, WDI/insects and/or pests/rodents. Brick may begin to fall from the chimney due to the failing mortar. Evaluate and replace as needed. (Red)

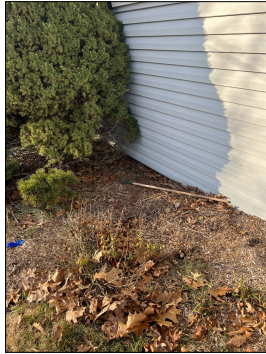
The grade was sloped towards the home or settled in areas. Proper grading should be complete to direct water from around the structure and away from the home. This will help prevent water accumulation against or under the home. Recommend review and repairs. Evaluate and repair as needed. (Purple) Location: Front of home Right side of home

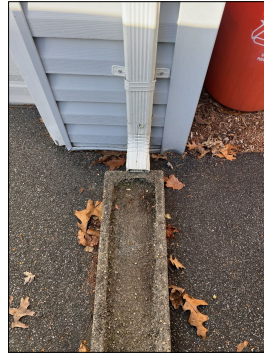
Splash blocks in place but should face away from home and/or be placed under the downspout to divert water away from the foundation and/or stairs. During the winter months the stairs/walkways may freeze becoming a trip hazard. Moss and/or algae growth may occur during the warmer wetter months making stairs/walkways slippery and becoming a trip hazard. Maintain and redirect as needed. (Blue)

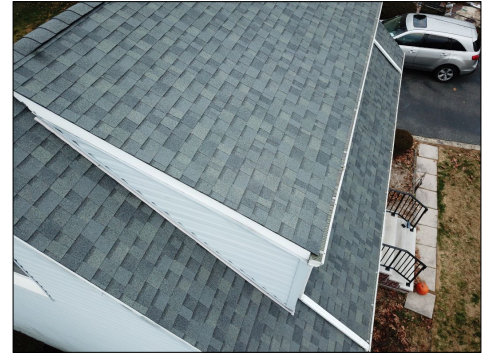
Unable to determine if debris is in gutters due to gutter guards being in place. These areas are excluded from the report. Recommend review to determine condition of gutters.

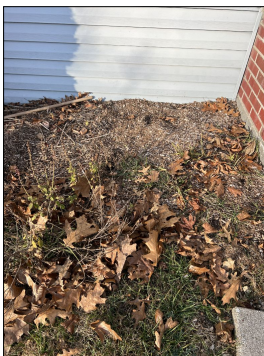
Soil/vegetation in contact or close contact with siding/trim components an 8"-10" clearance should be maintained to prevent intrusion of moisture, WDI/insects and/or pests/rodents. Remove to evaluate if any damage has occurred or to prevent damage from occurring. Repair or replace as needed. (Purple)  
Location:Around the structure

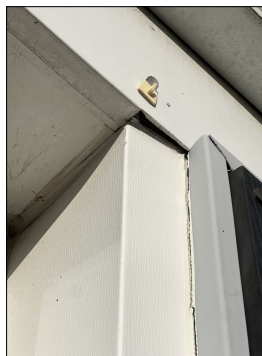
Seal gaps, cracks and penetrations at the exterior walls and trim to prevent moisture, WDI and pest intrusion. Evaluate and repair as needed. (Blue)

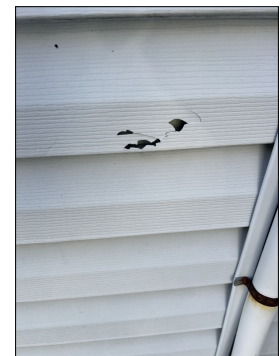
Minor defects and damages to cladding/trim. Small openings, cracks and/or minor separation. Evaluate and repair or replace as needed. (Blue)

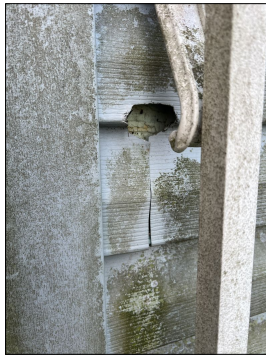
Openings , Damages observed at exterior wall/cladding and/or trim. Recommend sealing any gaps or openings to prevent unwanted moisture intrusion, rodent/pest intrusion and/or WDI intrusion and/or premature deterioration of sheathing. Evaluate and repair. (Blue)

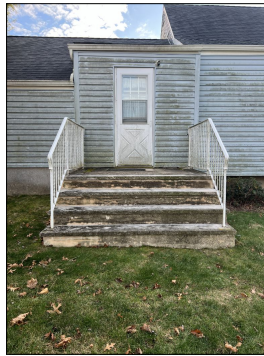
Algae/moss growth observed on the side of the home. This is common and should be removed. Algae can be removed with a soap and water mixture, moss can be treated with a moss killer during the wet months of the year. (Blue)

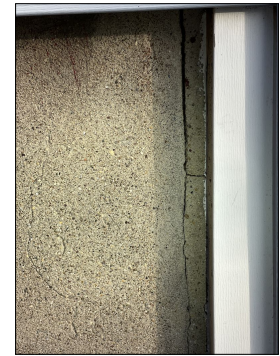
Parge coat on the exterior foundation wall was Cracked , Damaged and is in need of repair. Recommend review for cause of damages prior to repairs. (Blue)

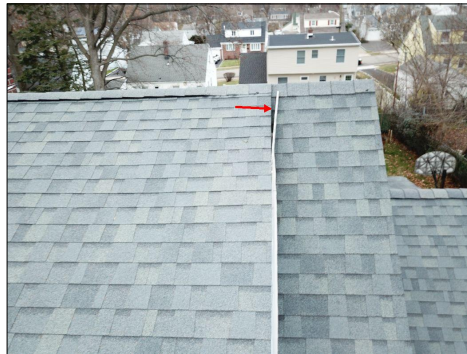
Damaged Rake edge observed, this can lead to premature rot of roof material, siding and/or sheathing due to water intrusion, pest/rodent intrusion and/or WDI intrusion. Evaluate and repair to prevent further damage. (Red) Location: Right side of home

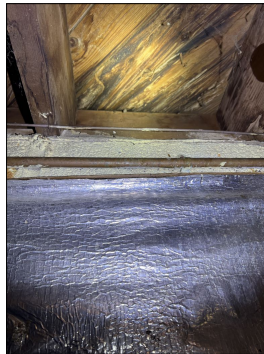
Water stains at sub floor/floor joists, Recommend determining the cause of water damage and making the appropriate repairs. Unable to get a moisture reading at the time of the inspection. Any associated damage (plumbing or source of water) should be corrected. Evaluate and repair or replace as needed. (Purple)  
Location: Basement

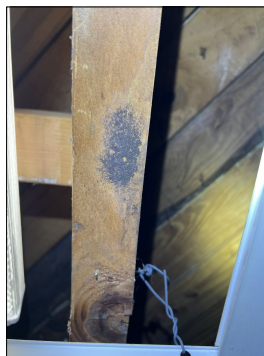
Micro bacterial growth observed on the sub floor and/or floor joists at the time of inspection. Recommend testing. (Purple)

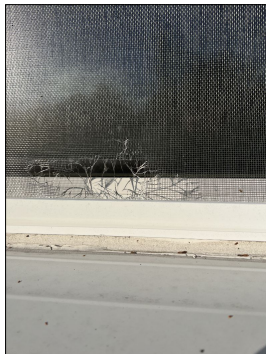
Damaged window screens. Repair or replace as needed. (Blue) Location: Review all windows

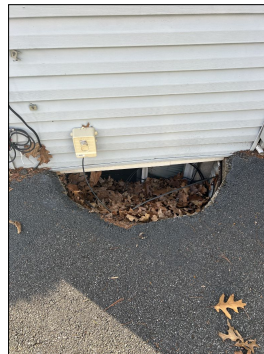
The window well cover was missing, recommend installing window well cover to prevent water intrusion, foliage and/or vegetation growth. Evaluate and replace as needed. (Purple)

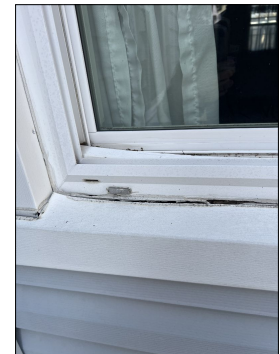
Caulk was damaged at time of inspection. Maintain caulk at exterior window trim, to help prevent intrusion of water, pests/rodents and/or WDI. Evaluate, maintain and/or repair as needed. (Blue)

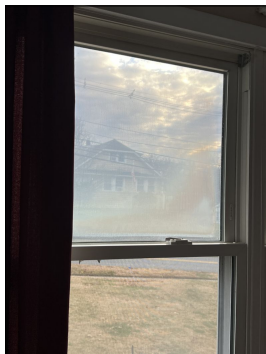
Condensation, staining or fogged glass at double pane windows typically indicates a broken seal between the panes. Repair or replace as needed. (Blue) Location: Review all windows

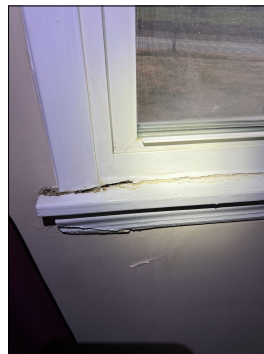
Water penetration observed at the wall below the window and damage consistent with water at window trim. Unable to determine if the windows were properly sealed. Recommend sealing and maintaining the seal. Recommend review of the window to determine if the installation is correct. Evaluate and repair or replace as needed. (Red)

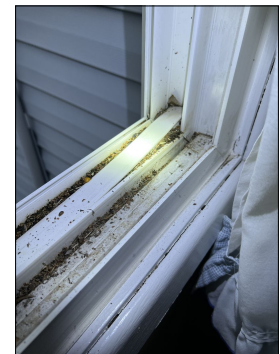
Damaged window components observed. It appears as if nesting occurred in the window. Recommend sealing any gaps or openings around the exterior of the home. Evaluate, treat and repair as needed. (Blue)

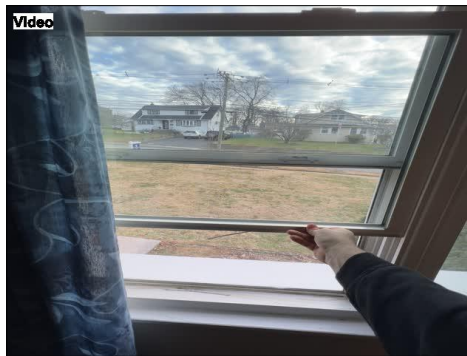
Double hung window would not stay up when opened. Repair to prevent injury. (Red) Location: review all windows. Throughout the home.

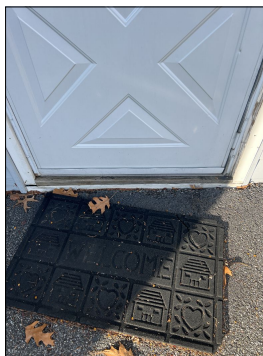
Recommend maintaining paint or sealing at the door sill and/or any exposed wood at the door and/or around door to prevent damage due to moisture or WDI. Recommend routine maintenance on all exterior wood. Evaluate and repair. (Blue)

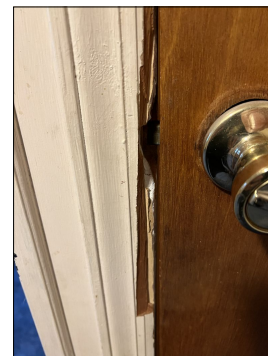
Moderate damage to door(s). Door doesn't latch, missing hardware and/or other minor to moderate defects. Replacement may be necessary. Evaluate and replace as needed. (Purple) Location: Second floor Bedroom 2

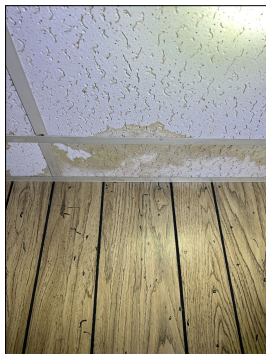
Evidence of previous leaks or moisture intrusion observed, no moisture reading taken at the time of inspection. Water stains were observed. Recommend determining if a leak still exists and if so make the proper repair to prevent further damage. Evaluate and repair as needed. (Purple)

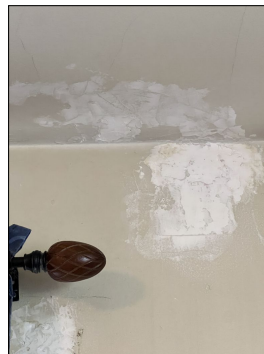
Repairs made to wall appeared to be done in a typical "DIY" fashion and are below industry standards. Plaster or drywall was left unfinished and/or cracking. Evaluate and repair. (Blue)

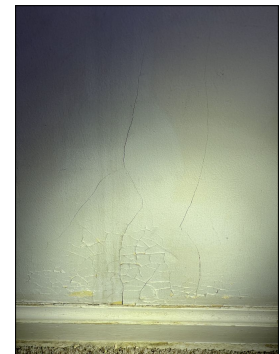
Due to the age of the home, the first coat of paint may contain lead. Only laboratory testing can determine if lead based paint is present. Keeping the intact paint covered is considered safe in most cases. If renovations are to be done, the proper methods should be explored for removal and disposal of the paint. (Purple)

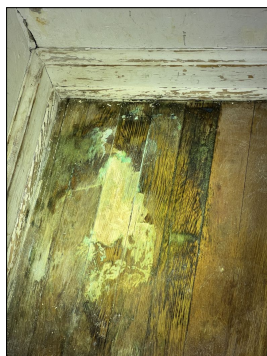
Discoloration observed at the floor boards. Areas of the hardwood floor appeared to be damaged and appears to be cosmetic. Evaluate and replace as needed. (Purple)

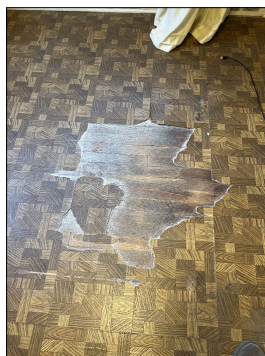
Laminate and/or vinyl floors were Damaged. Repairs should be made to prevent slips, trips or falls. Evaluate and repair as needed. (Blue)

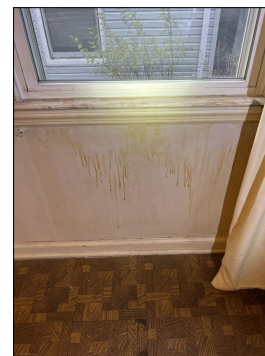
Discoloration or defects at walls. Normal moisture levels at time of inspection. Location: Main floor Bedroom 2

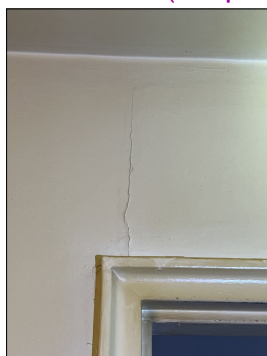
Minor to moderate defects or damage to walls; cracking plaster or drywall, tape joints peeling and/or popping nails, damaged drywall. Recommend adding a door stop behind the door to prevent the hardware from hitting the wall. Repair as needed. (Blue)

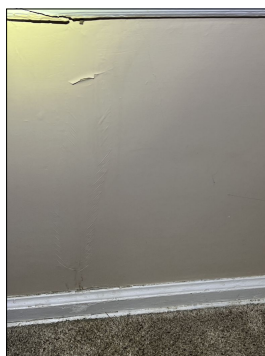
Signs of previous water damage or leaks at walls. Walls were dry at the time of inspection. Recommend determining if a moisture source is still present and repair as needed. Evaluate and repair as needed. (Purple)

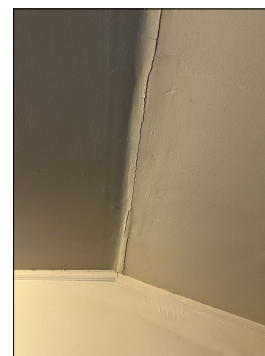
Tape joint(s) were peeling or damaged. This is not a typical sign of structural movement in most cases. This is usually a cosmetic defect caused by expansion and contraction due to change in temperature. Evaluate and repair. (Blue)

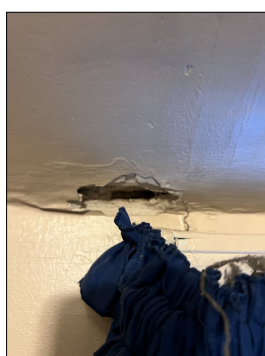
Openings observed in the drywall. Not a major concern, typically. Unless water intrusion or other defects couple with the damages. No signs of other defects. Recommend repairs. Evaluate and repair as needed. (Blue)

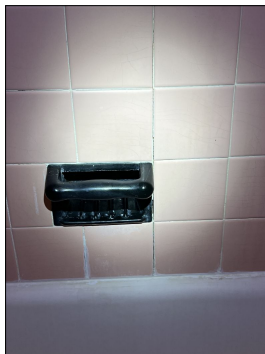
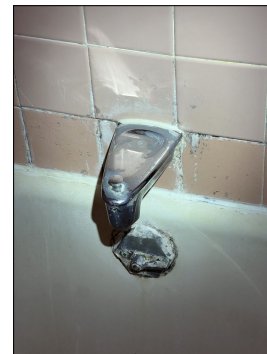
Bulging tiles and missing grout observed. Repairs should be made to prevent moisture intrusion behind walls and/or under floor tiles, which may promote micro bacterial growth. Areas behind tiles or finish material are not visible at the time of inspection and are excluded from the report. Repair or replace as needed. (Purple) Location: Bathroom

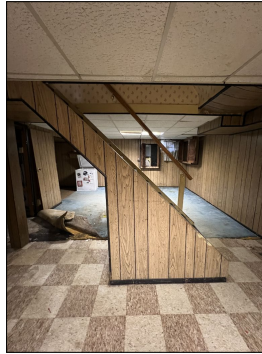
No safety rail or balusters at the stairs, this can be a safety hazard and not up to industry standards. Install to prevent injuries. Evaluate and install. (Red)

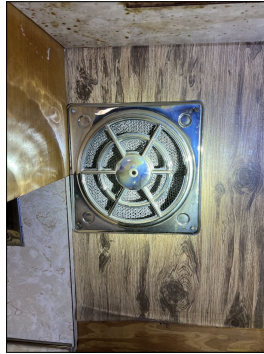
No power source observed at the vent. Recommend determining if an on/off switch is present and determining if the vent is operable. Evaluate and repair as needed. (Blue)

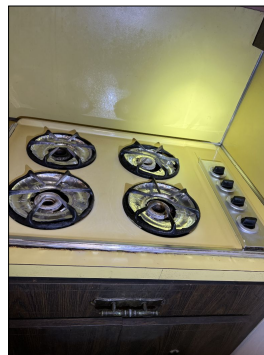
Cook top and oven appeared to be an older unit and may be near the end of its lifespan. Recommend updating.

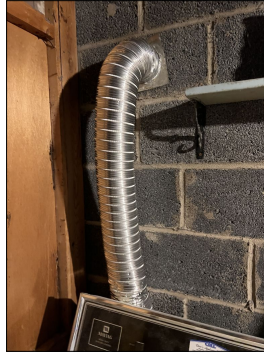
Dryer vent is a flex style pipe, recommend upgrading to a smooth wall, solid pipe to prevent crushing. Flex pipes are prone to crushing and can block/trap lint, raising the risk for a potential fire. (Red)

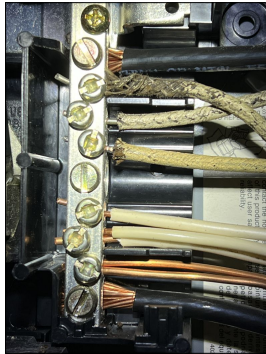
Double tapped neutral - more than 1 neutral wire at a lug at the neutral bus bar. Repair. (Red)  
Location: Main service panel Unit 2 sub panel

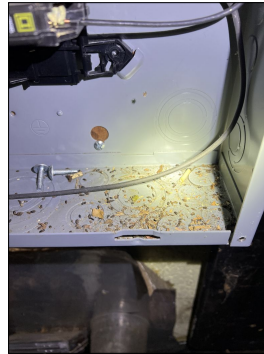
Rodent droppings or signs of rodents were observed in the breaker panel box at the time of inspection. Recommend having any access to the panel sealed to prevent intrusion of pests that can lead to damaged wiring. Evaluate and repair as needed. (Blue)

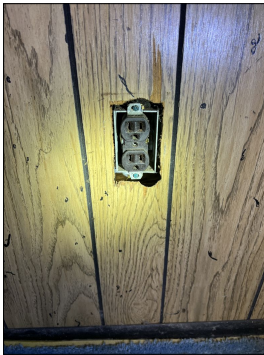
Missing outlet/switch cover plate(s). Replace for safety. (Red)

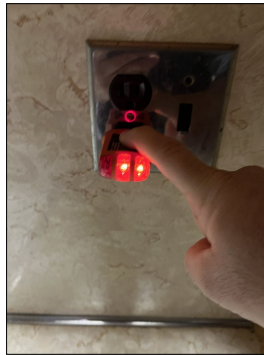
Outlet did not respond to GFI test and did not appear to be GFI protected. Outlets within 6' of a water source should have GFCI protected outlets installed. (Red) Location: Review all outlets.

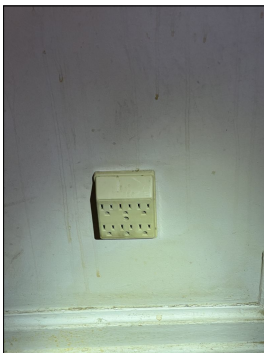
It is recommended to avoid use of multiplier outlet plug ins(converts 2 into 6 outlets). Unable to test outlet and/or verify if the outlet is GFCI protected(only in locations where needed). Recommend removing and replacing as needed. (Blue)

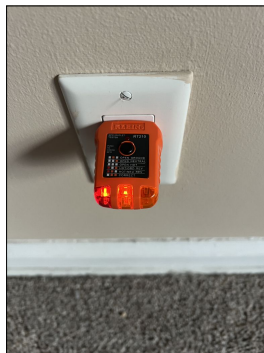
Outlet tester indicates reversed polarity. This typically means the black wire and white wire were incorrectly installed at the outlet. Evaluate. Repair or replace. (Red) Locations: Review all outlets. Living room

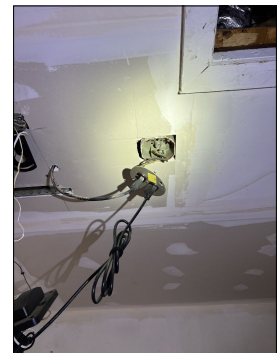
Install covers at open junction boxes or secure the cover to the box for safety. Evaluate and repair as needed. (Red)

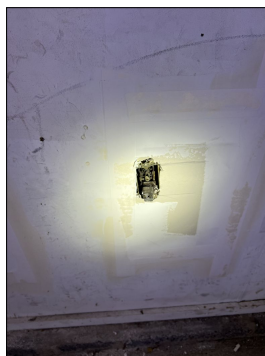
Damaged outlet observed. This outlet has failed and presents a safety hazard. Evaluate and replace for safety. (Red)

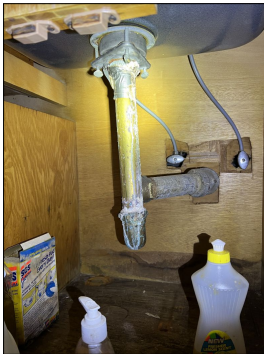
Moderate corrosion at drain lines. Leaking may occur if not repaired. Evaluate. Repair or replace as needed. (Purple)

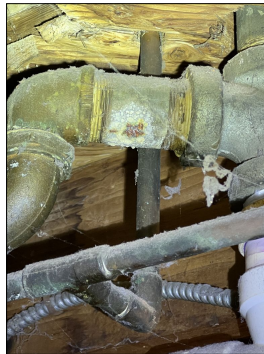
Rusted drain line piping. No leaks observed at the main drain line. The water was off at the time of inspection and no drains were tested for leaks. Replace as needed. (Red)

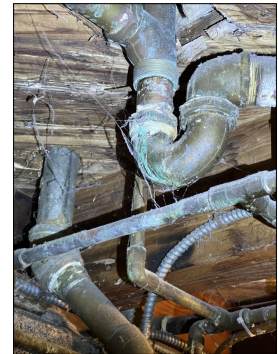
Moderate corrosion at drain lines. Leaking may occur if not repaired. Evaluate. Repair or replace as needed. (Purple)

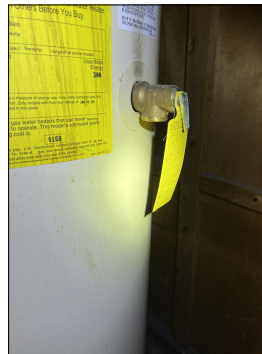
The extension pipe at the temperature pressure relief (TPR) valve was missing. Evaluate. Install per manufacturers specifications. (Red)
