# PROPERTY INSPECTION REPORT

**Robert Keesser**  
**Kee-Way Inspection Services**  
**24gl00181100**

**123 Inspection Rd.**

**Inspection prepared for: Sample Report**

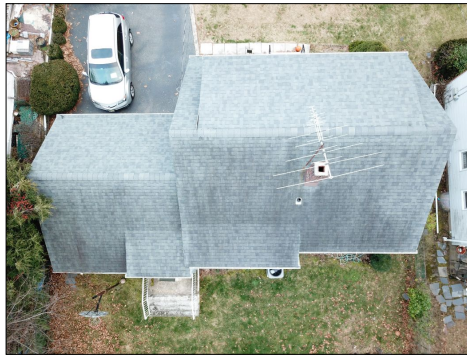
The brick and/or mortar at the chimney was damaged. Areas of mortar were missing, which can lead to intrusion of water, WDI/insects and/or pests/rodents. Brick may begin to fall from the chimney due to the failing mortar. Evaluate and replace as needed. (Red)

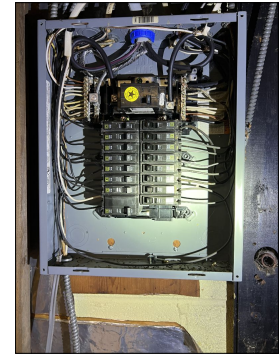
Rodent droppings or signs of rodents were observed in the breaker panel box at the time of inspection. Recommend having any access to the panel sealed to prevent intrusion of pests that can lead to damaged wiring. Evaluate and repair as needed. (Blue)

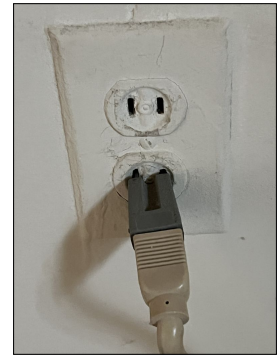
2 prong outlets are not typically grounded. Evaluate. Upgrading to current standards should be considered. (Purple) Location: Throughout the home.

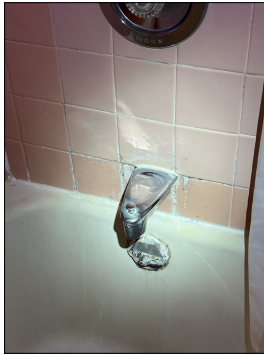
Stopper did not operate properly. The stopper appeared to be sealed or corroded. Recommend attaching or repairing for proper function. Repair as needed. (Blue)

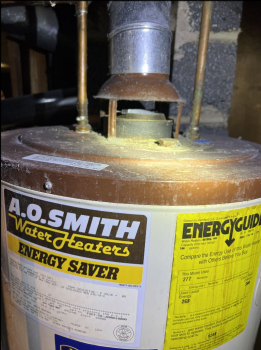
Moderate dust and/or dirt observed at the top of the water heater. This should be cleaned off as it is a possible fire hazard. Evaluate and clean as needed. (Purple)

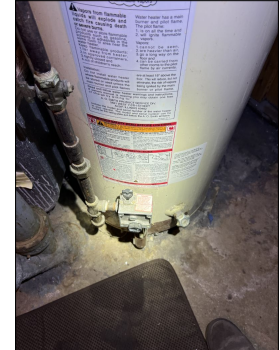
Highly recommend raising the unit(s) off of the floor. This may prevent premature rusting of the base. Raising it from the floor may increase efficiency of the unit. (Blue)

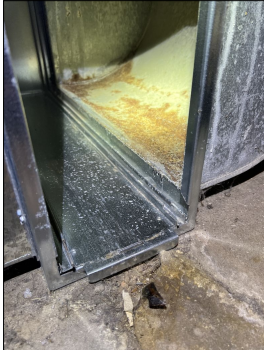
Rust noted in duct work. This may be caused by high humidity in the basement area. Review should be done to determine the severity of the rust on internal duct work components. Recommend review of the system by a licensed HVAC contractor prior to the end of the contingency period for. (Red)

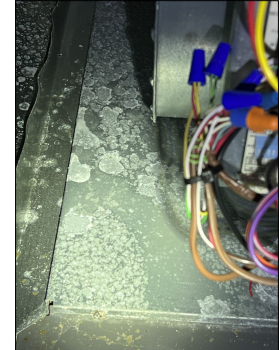
Scale observed in the service cabinet. This may be caused by excess condensation or leaking. Find the source and repair. Evaluate and repair or replace components as needed. (Purple)

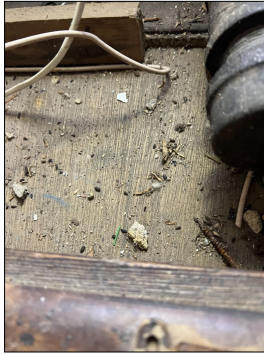
Rodents droppings observed. Recommend sealing any openings and treatment by a licensed pest control company. (Blue)

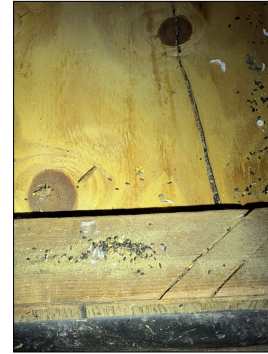
Rodents droppings observed. Recommend sealing any openings and treatment by a licensed pest control company. (Blue)
